Re: Tallyn Ridge – Combined Preliminary (AKA Glad Hill Property)  
File #S1166, Project Number 14144  
BCG Project # 5747-01-002  
FRO Staff Level Review

Issues associated with Specimen Tree 1- Refer to attached Photo Exhibit (Photo #s 1 – 25)

Issues associated with Specimen Tree 41- Refer to attached Photo Exhibit (Photo #s 26 – 36)

Issues associated with Specimen Trees 17, 18, and 19- Refer to attached Photo Exhibit (Photo #s 37 – 41)

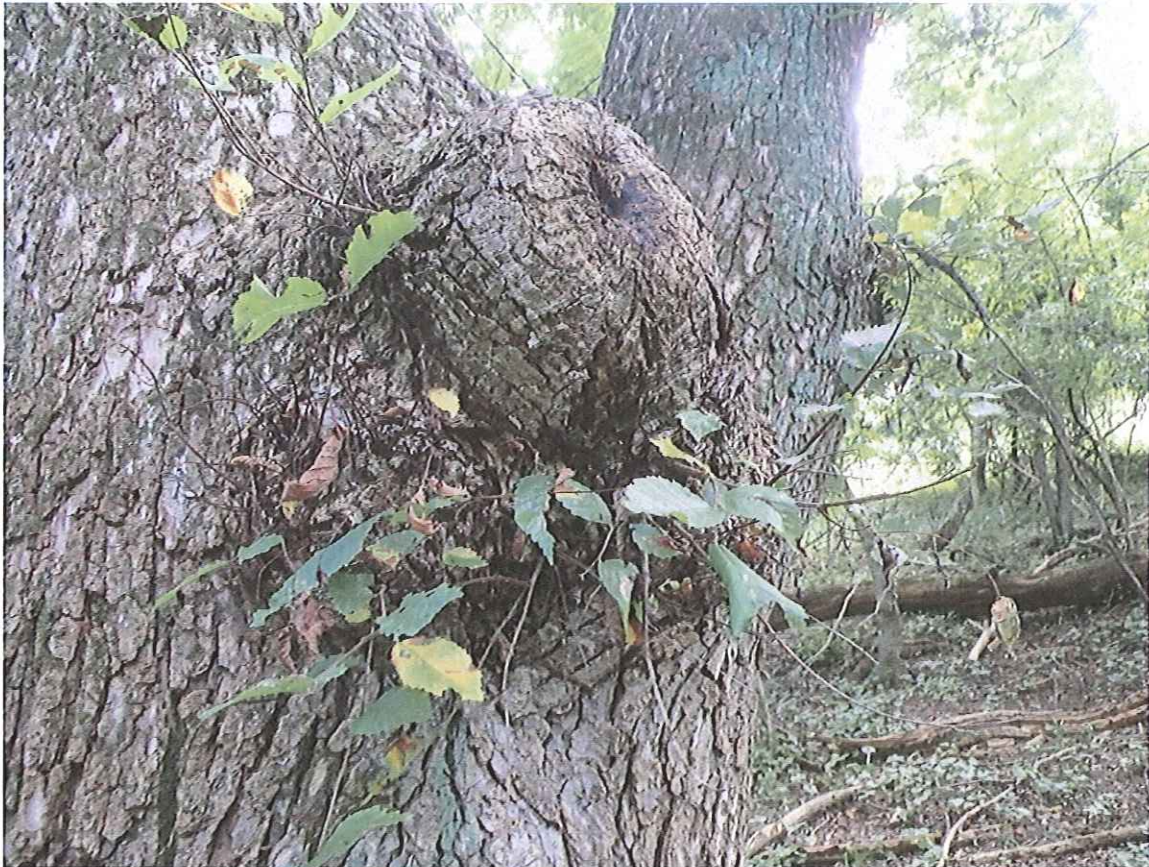
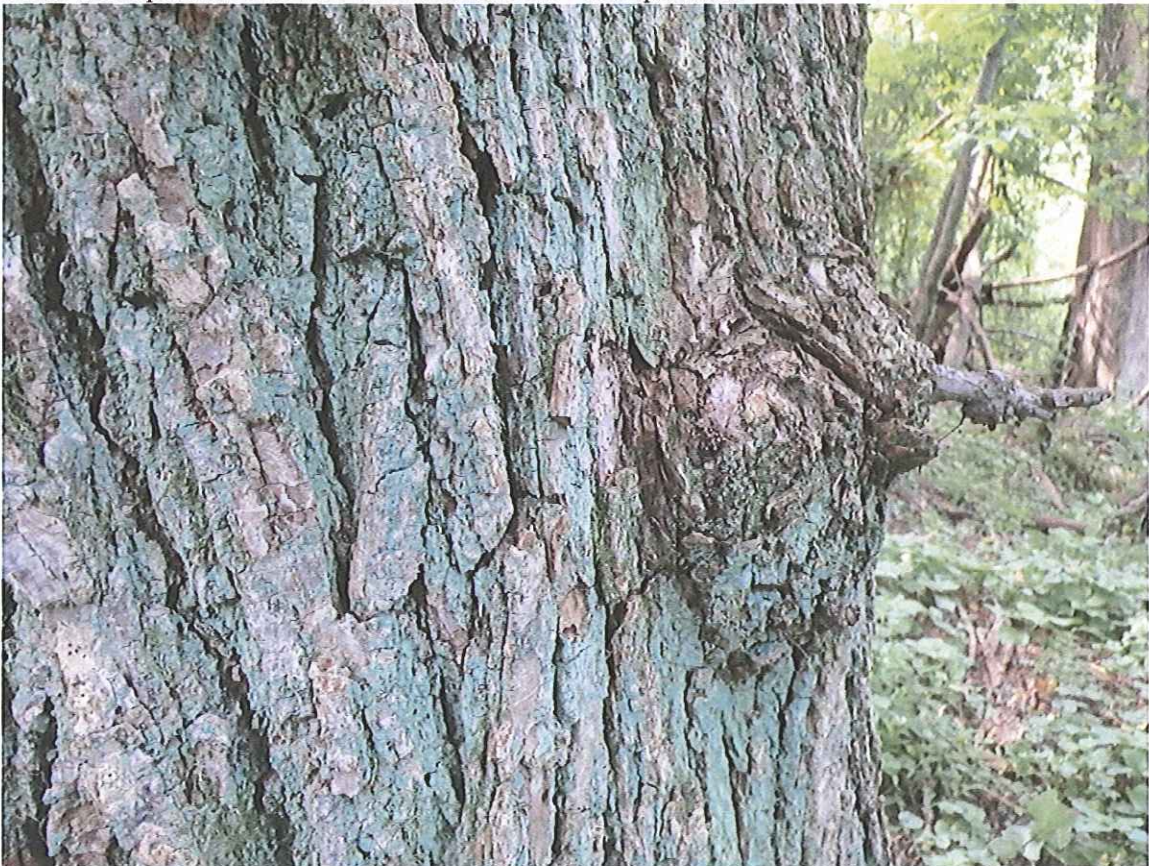
- Multiple burls - Burls, galls, and tumors may be caused by bacteria, fungi, insects, or environmental stress and could serve as secondary infection avenues for insects and disease. Burl wood in vulnerable spots or with off-shooting growth can become so large and heavy that they create additional stress on a tree and can cause the tree to break apart.

Photo #31: Specimen Tree #41. 30" American Elm – Multiple burls.

Photo #32: Specimen Tree #41. 30" American Elm – Multiple burls.

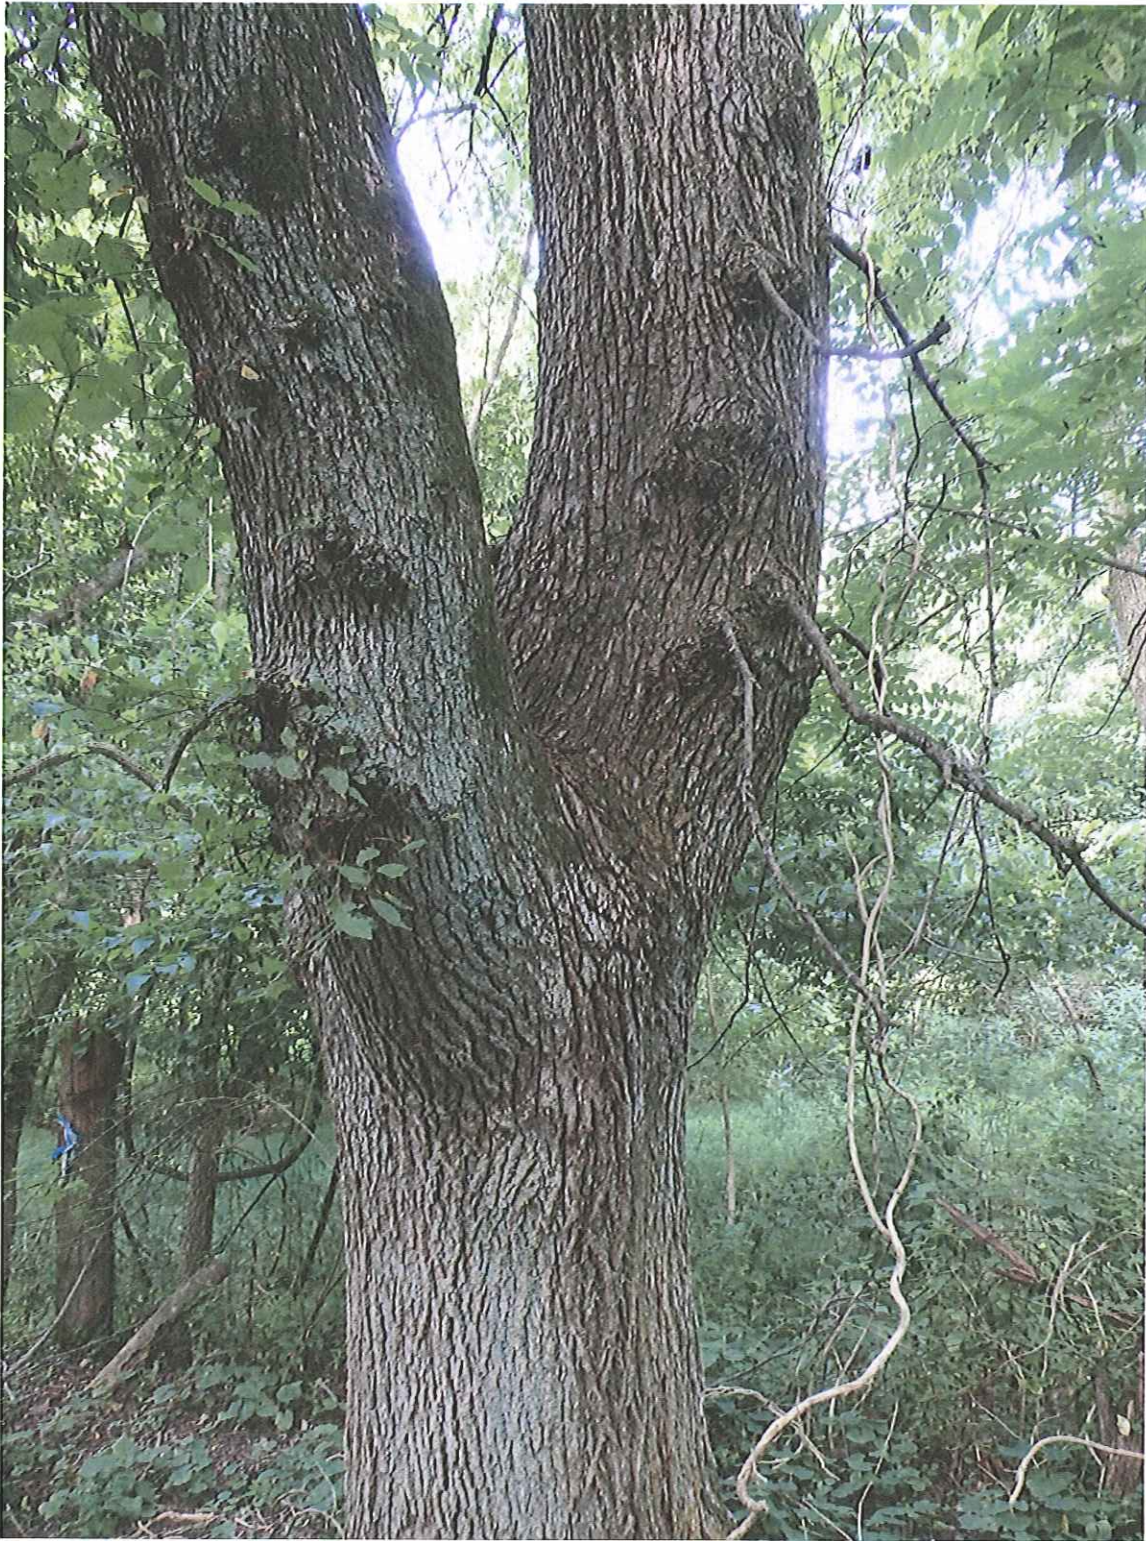
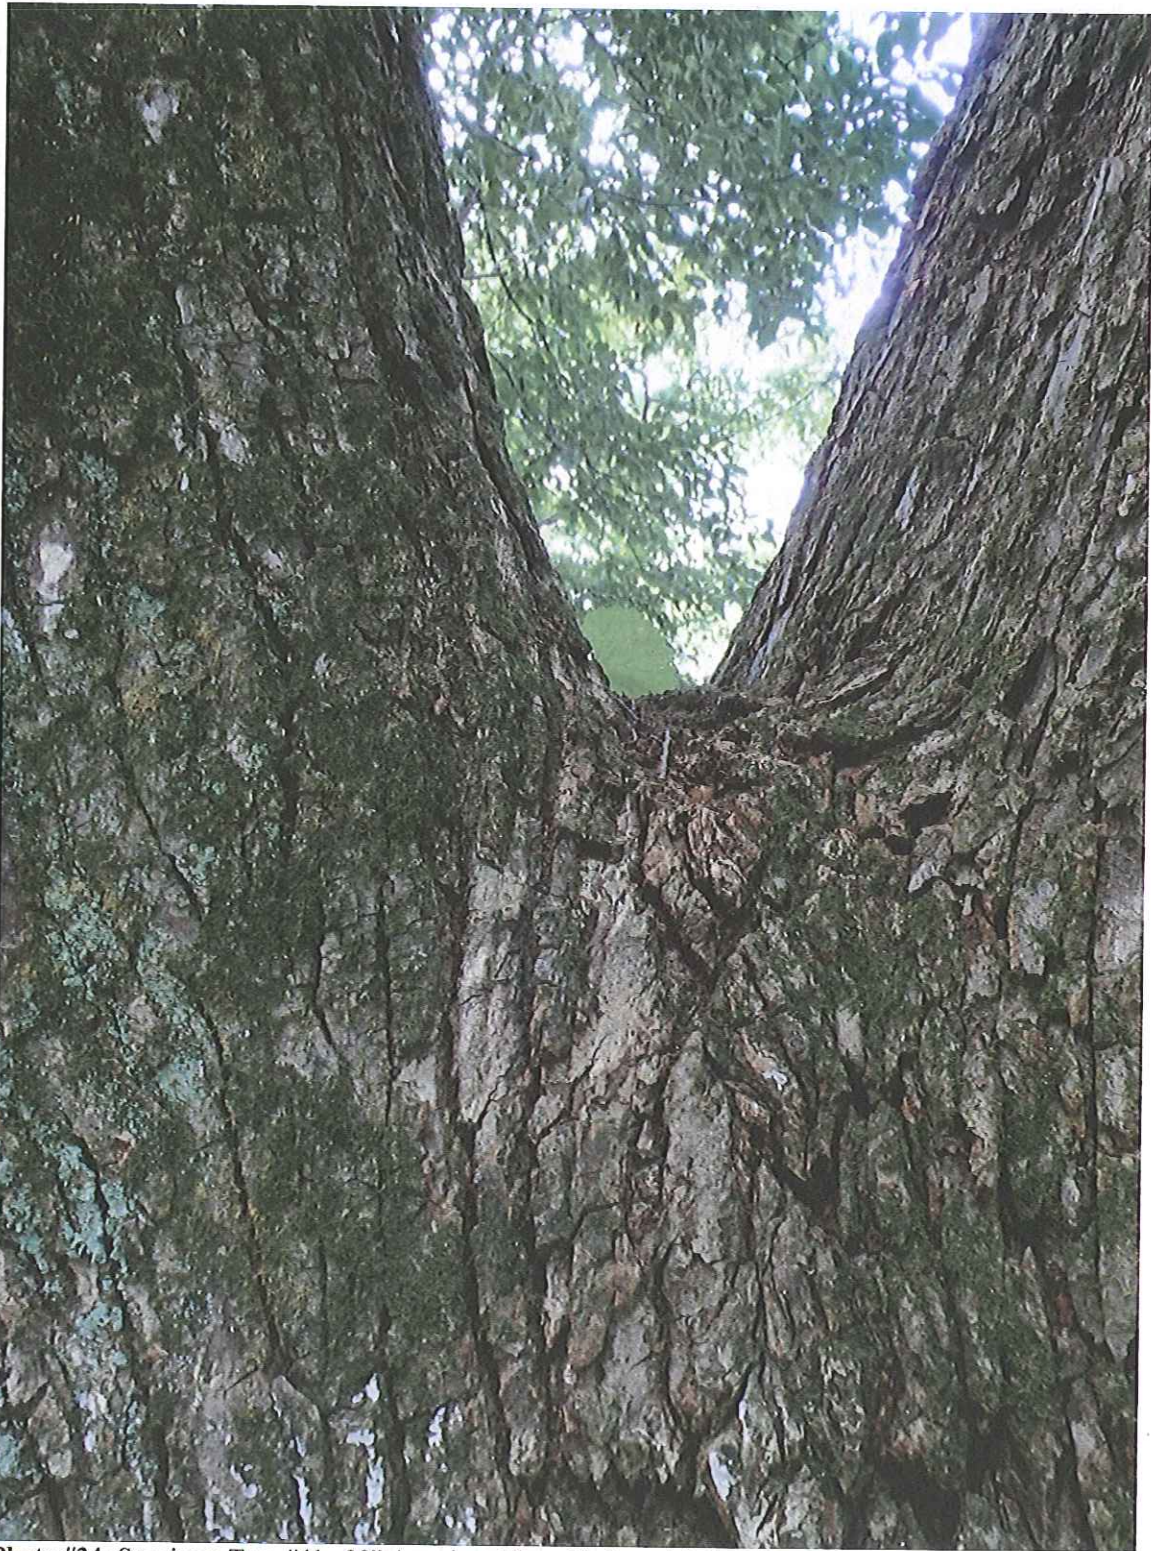
- V-shaped fork - Many times the union where the stems connect are weak potentially dangerous "V" shaped instead of stronger "U" shapes. This could allow splitting down the middle.

**Photo #33:** Specimen Tree #41. 30" American Elm – V-shaped fork.

Photo #34: Specimen Tree #41. 30" American Elm – V-shaped fork.

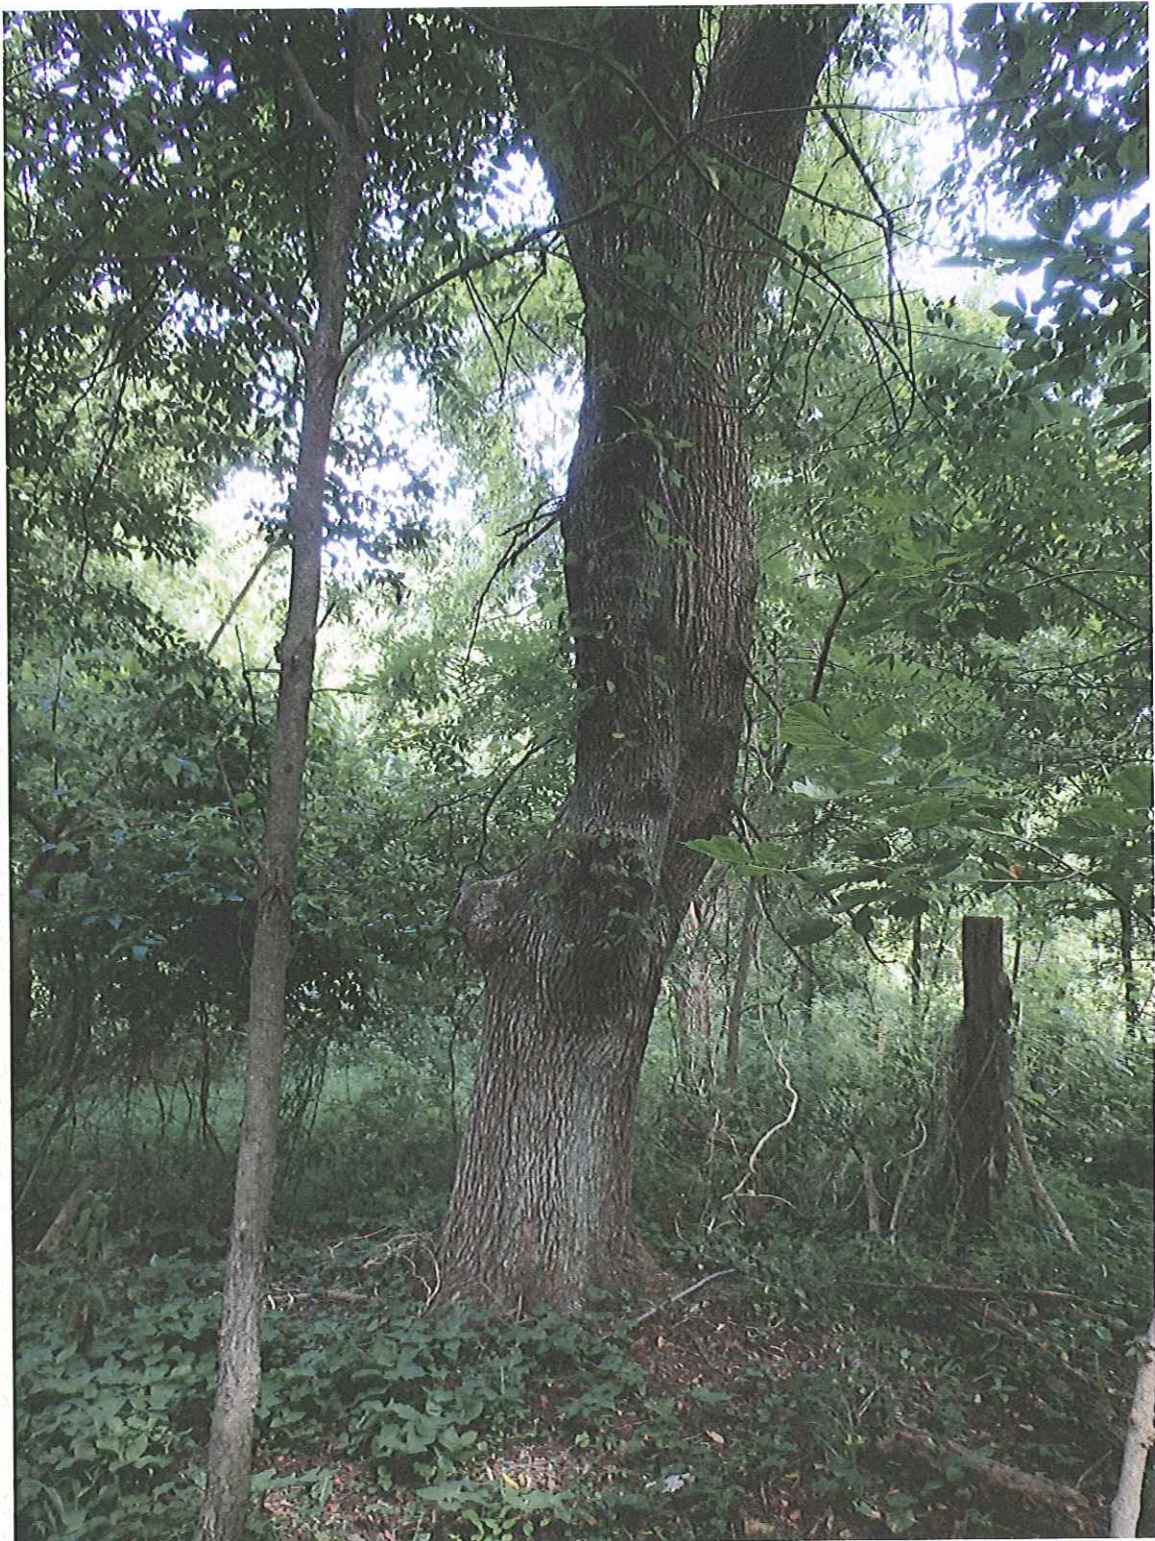
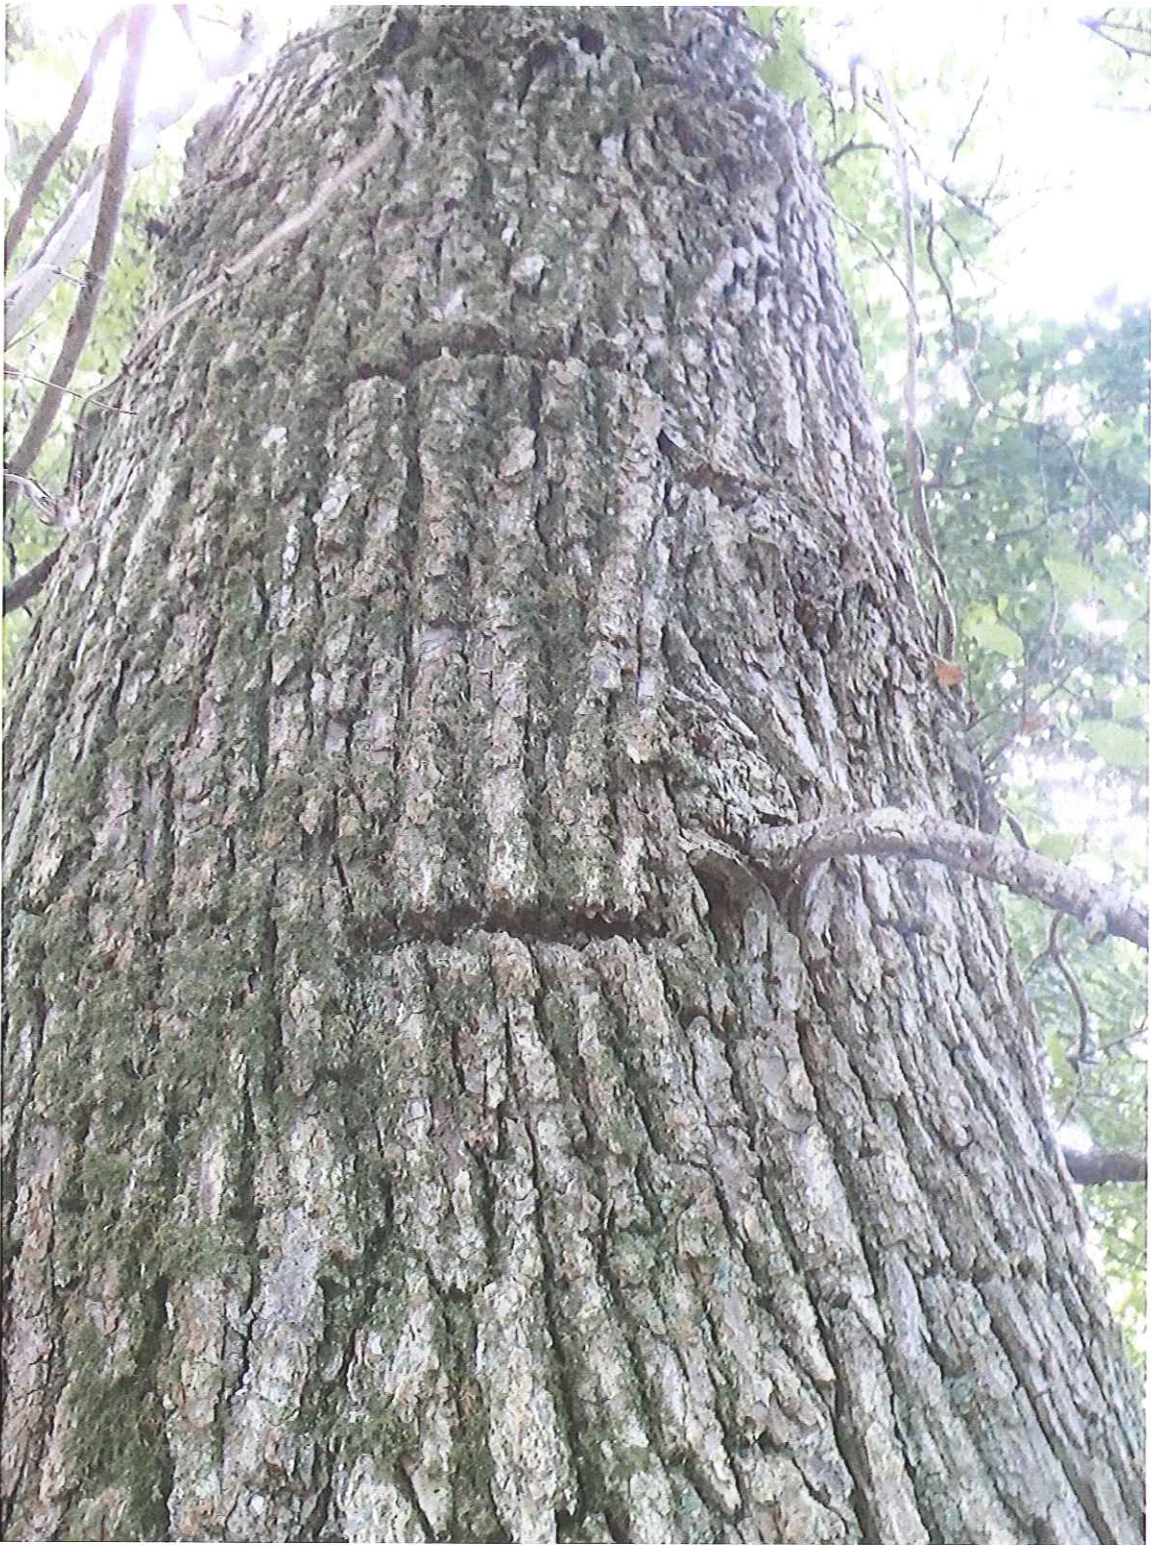
- Irregular lean habit - The greater the lean, the greater the probability of failure during wind gusts or snow loads.
- Multiple seams - Potential indicator of tree decay. Vertical cracks can be caused by a variety of reasons, may be associated with decay and will eventually fail. They suggest an internal defect, usually an old wound. The wound creates a weakened place in the wood that is prone to cracking and splitting, especially when the trunk is under stress by winds or abrupt changes in temperature. Horizontal cracks indicate that the tree is already failing and should be removed as soon as possible.

Photo #35: Specimen Tree #41. 30" American Elm – Irregular lean habit.

Photo #36: Specimen Tree #41. 30" American Elm – Multiple seams.

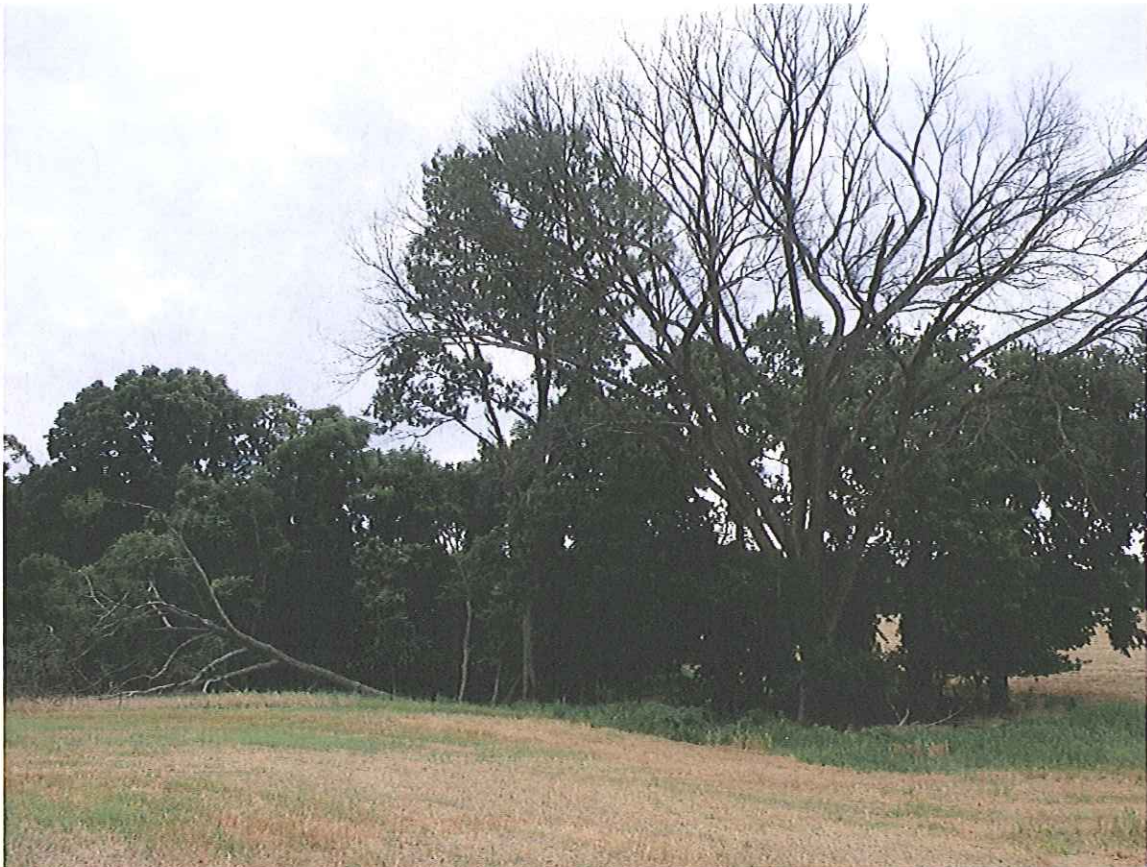
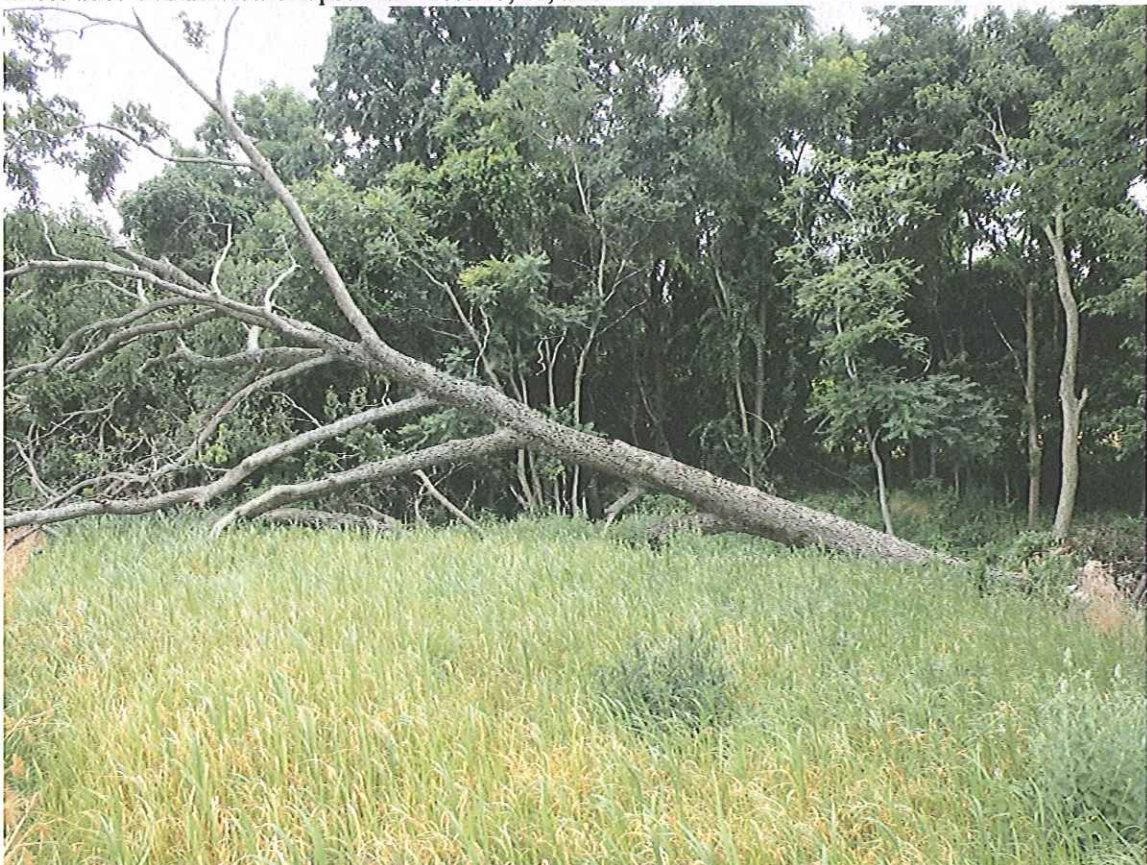
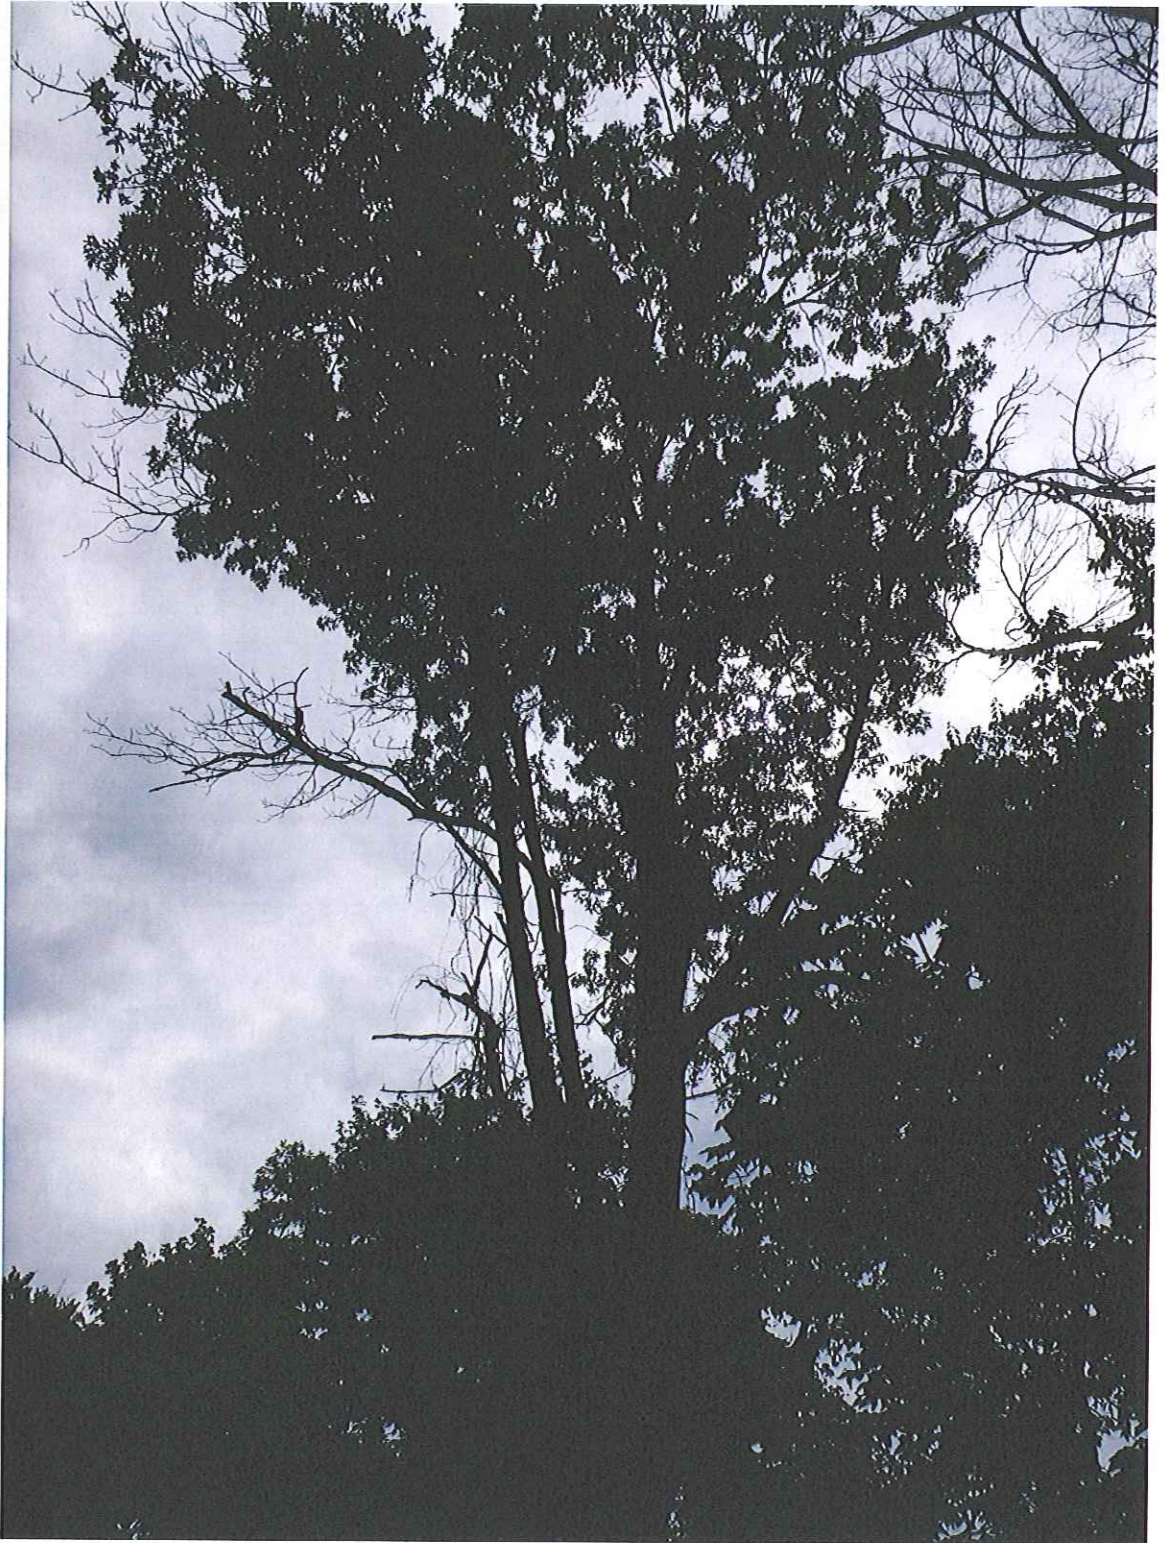
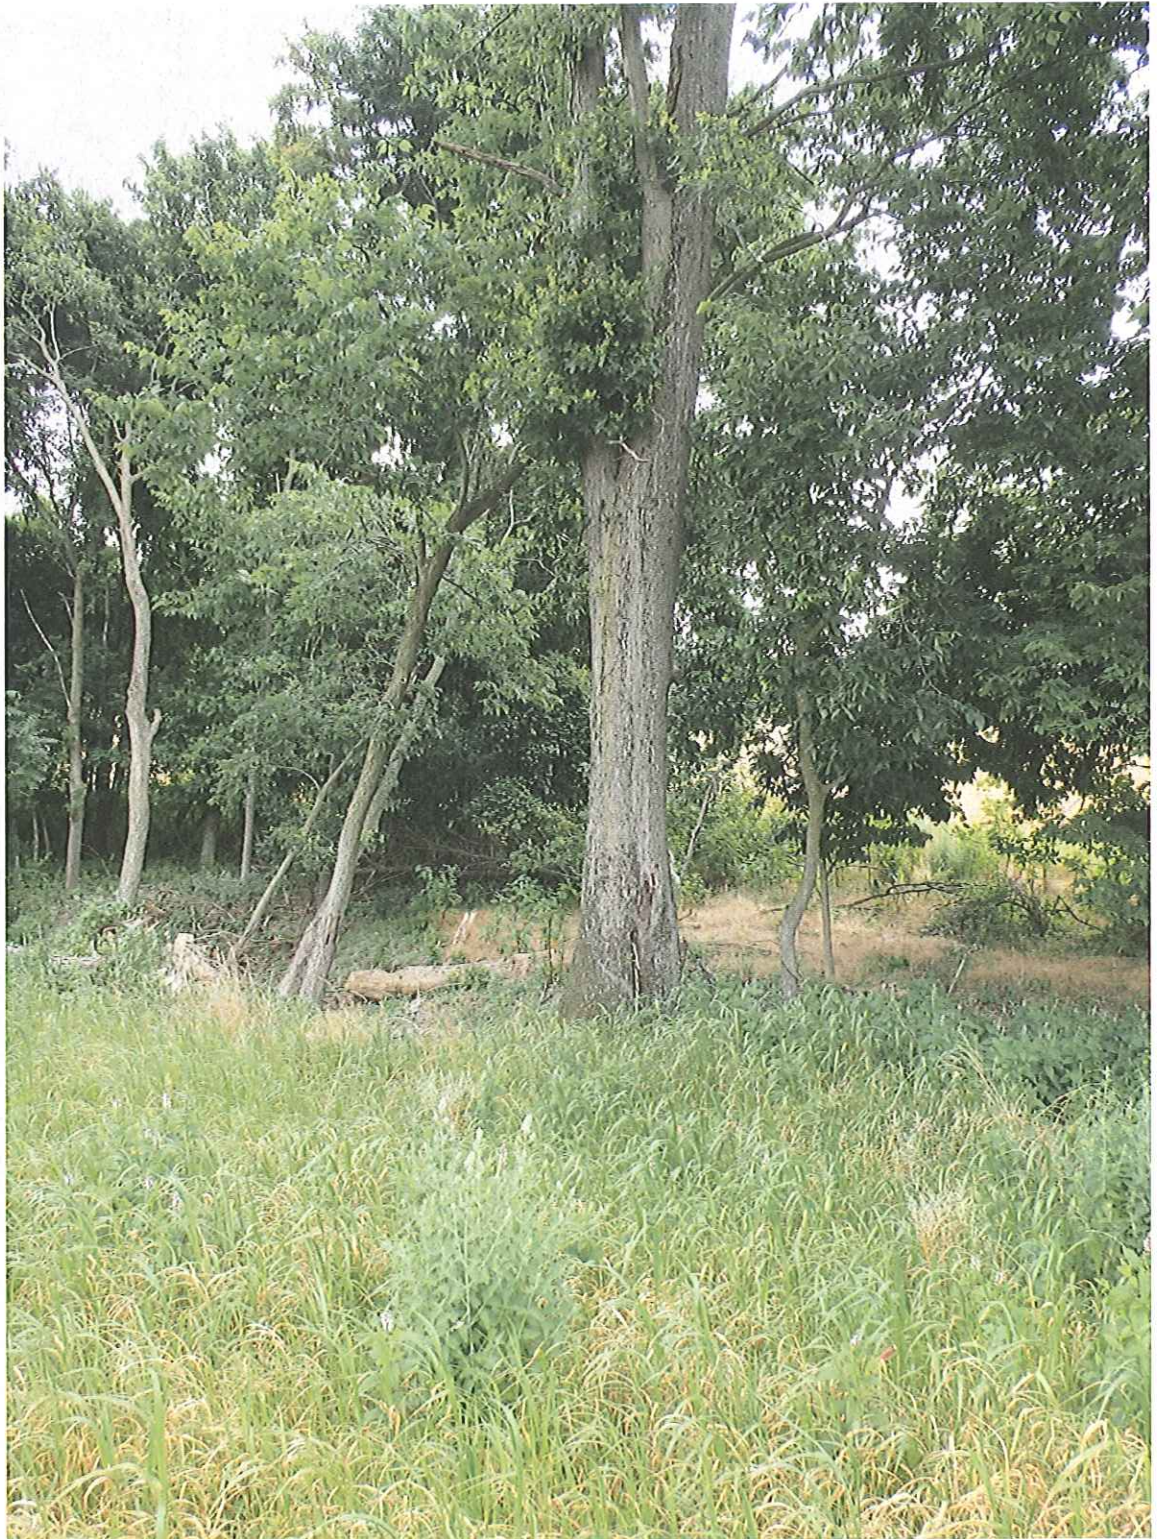
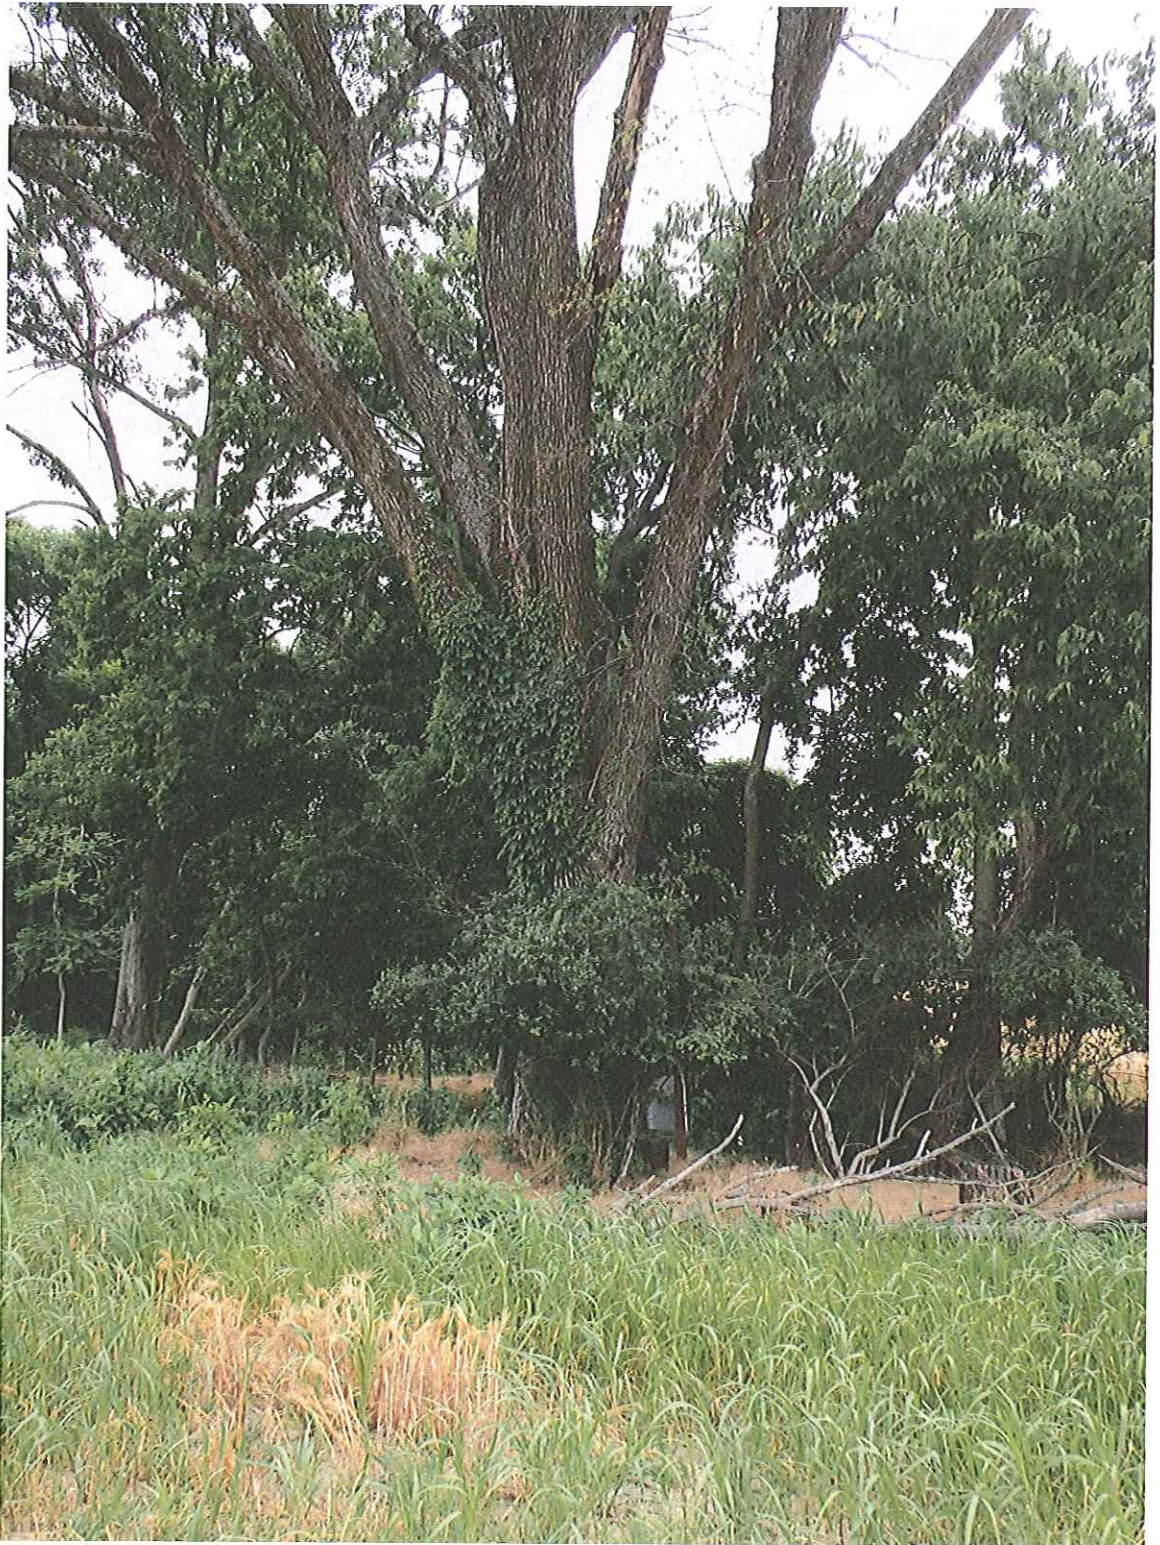
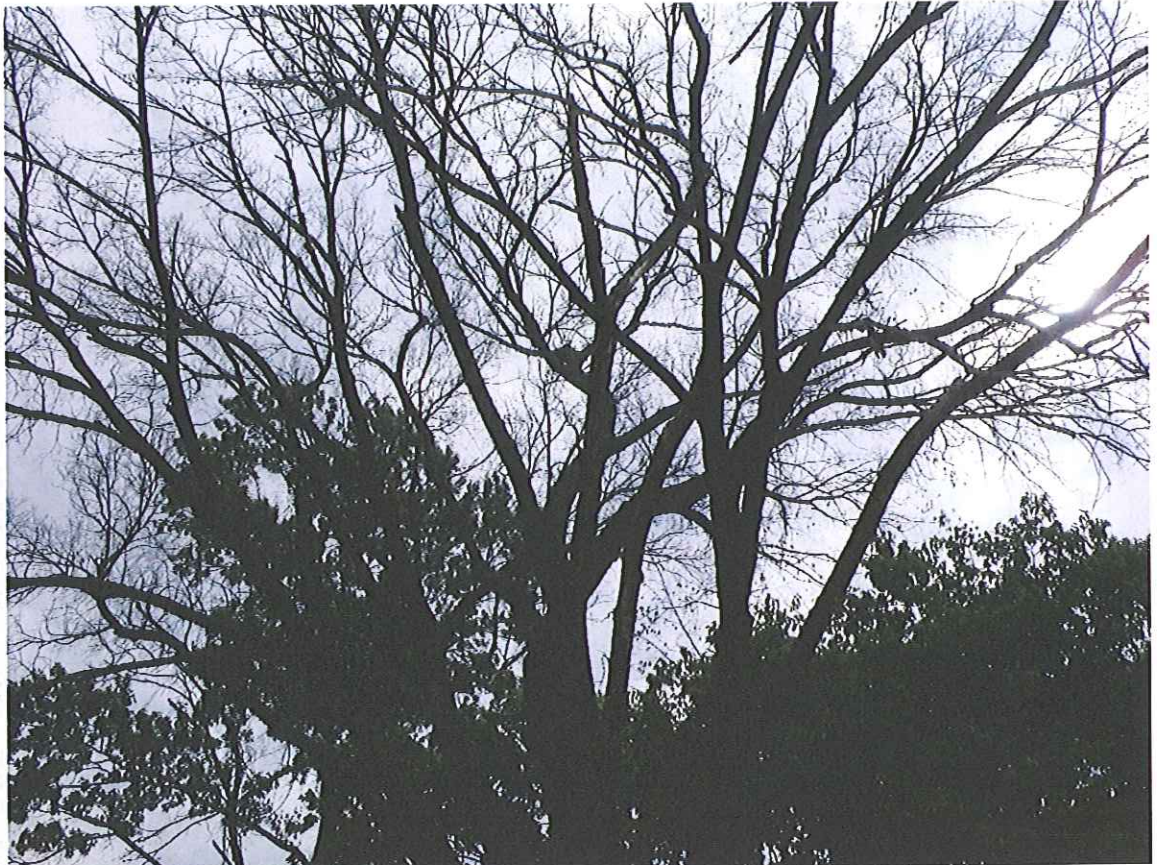
- Tree 17 has fallen
- Tree 18 is in serious decline
  - Half dead canopy
  - Cankers at base
  - Presence of fungus
- Tree 19 is dead

**Photo #37:** Overall view of Specimen Trees 17, 18, and 19

**Photo #37:** Specimen Tree #17. 30" Hackberry (previously identified as good).

**Photo #38:** Specimen Tree #18. 30" Northern Red Oak (previously identified as fair).

**Photo #39:** Specimen Tree #18. 30" Northern Red Oak (previously identified as fair).

**Photo #40:** Specimen Tree #19. 42" Northern Red Oak (previously identified as fair).

**Photo #41:** Specimen Tree #19. 42" Northern Red Oak (previously identified as fair).

During this visit, we also observed three (3) specimen trees that have seriously declined since the first survey was conducted in April 2013. For your reference, we have included photographic documentation regarding trees 17 (good), 18 (fair), and 19 (fair). We will be updating the FCP as necessary, to reflect current conditions of these trees.
